Old Stove Issues

Repairing Door Corner Cracks

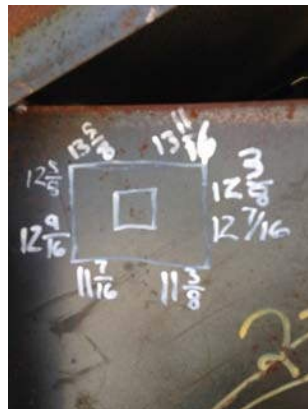
First we remove the front barn steel to expose the front plate. We then take detailed measurements of the front door to insure that we can replace it in its exact location on reassembly.

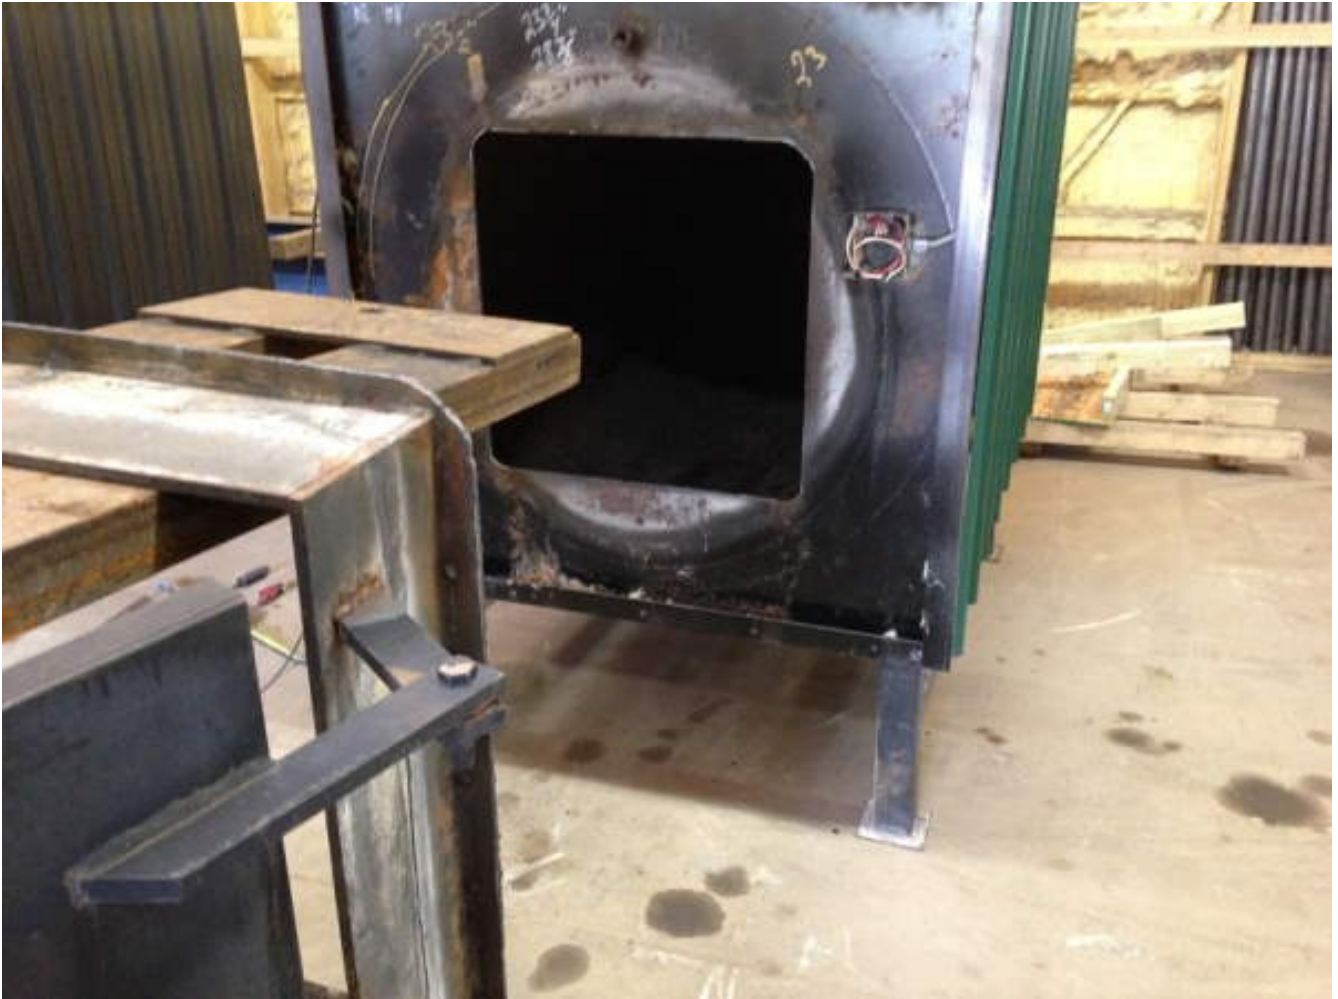
Next we cut the door and door frame from the stove, leaving about an inch of the front plate attached. This will be used to re-weld it to the new plate later. At this time we also repair any damage to the door frame, and any cracks or plate separation.

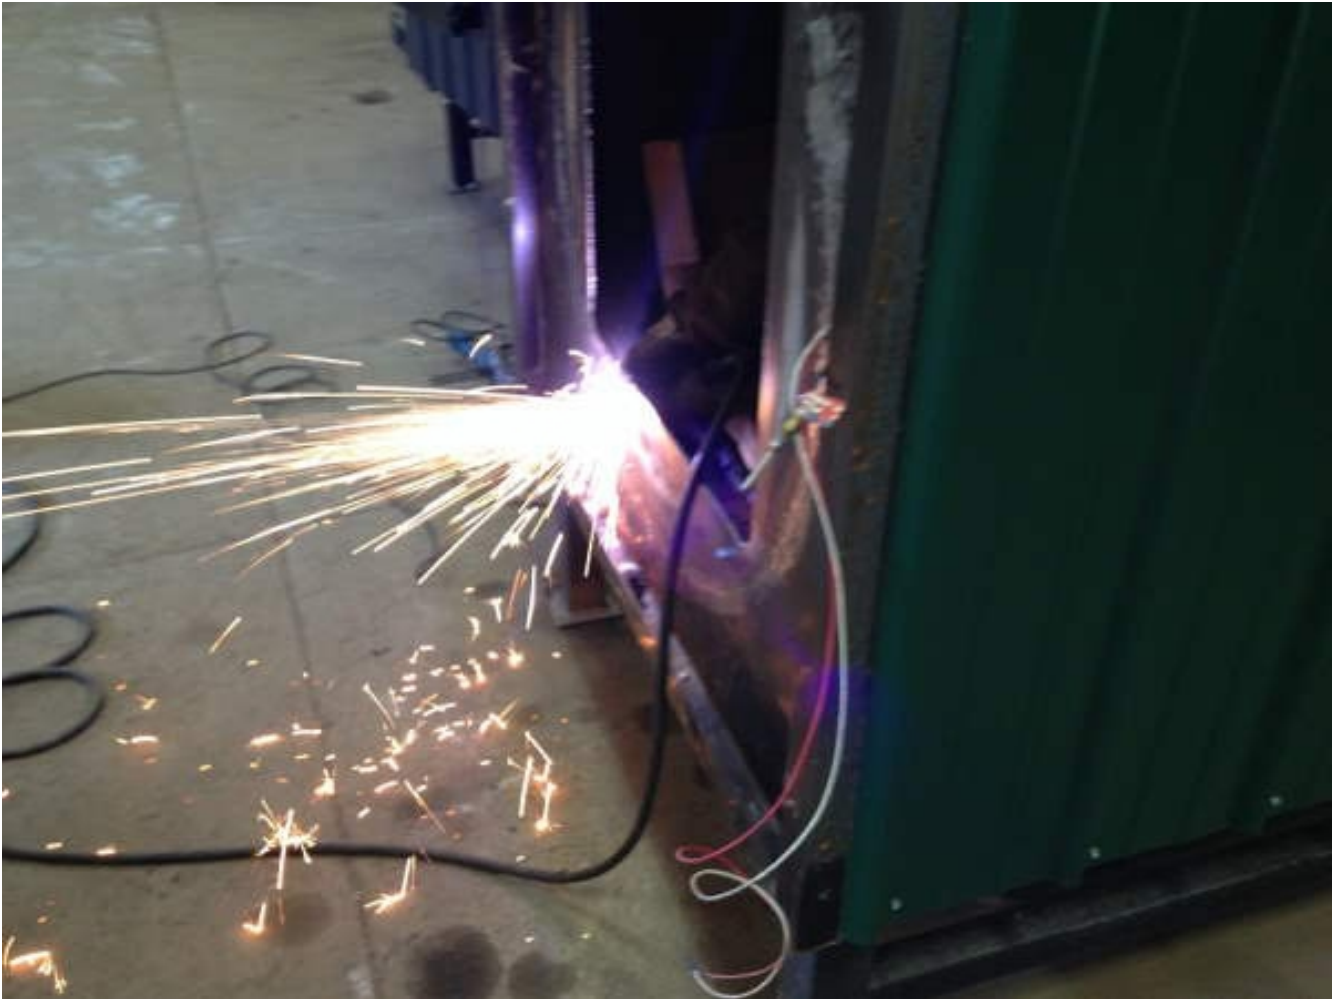
Then we cut the existing front plate out to the edge of the firebox.

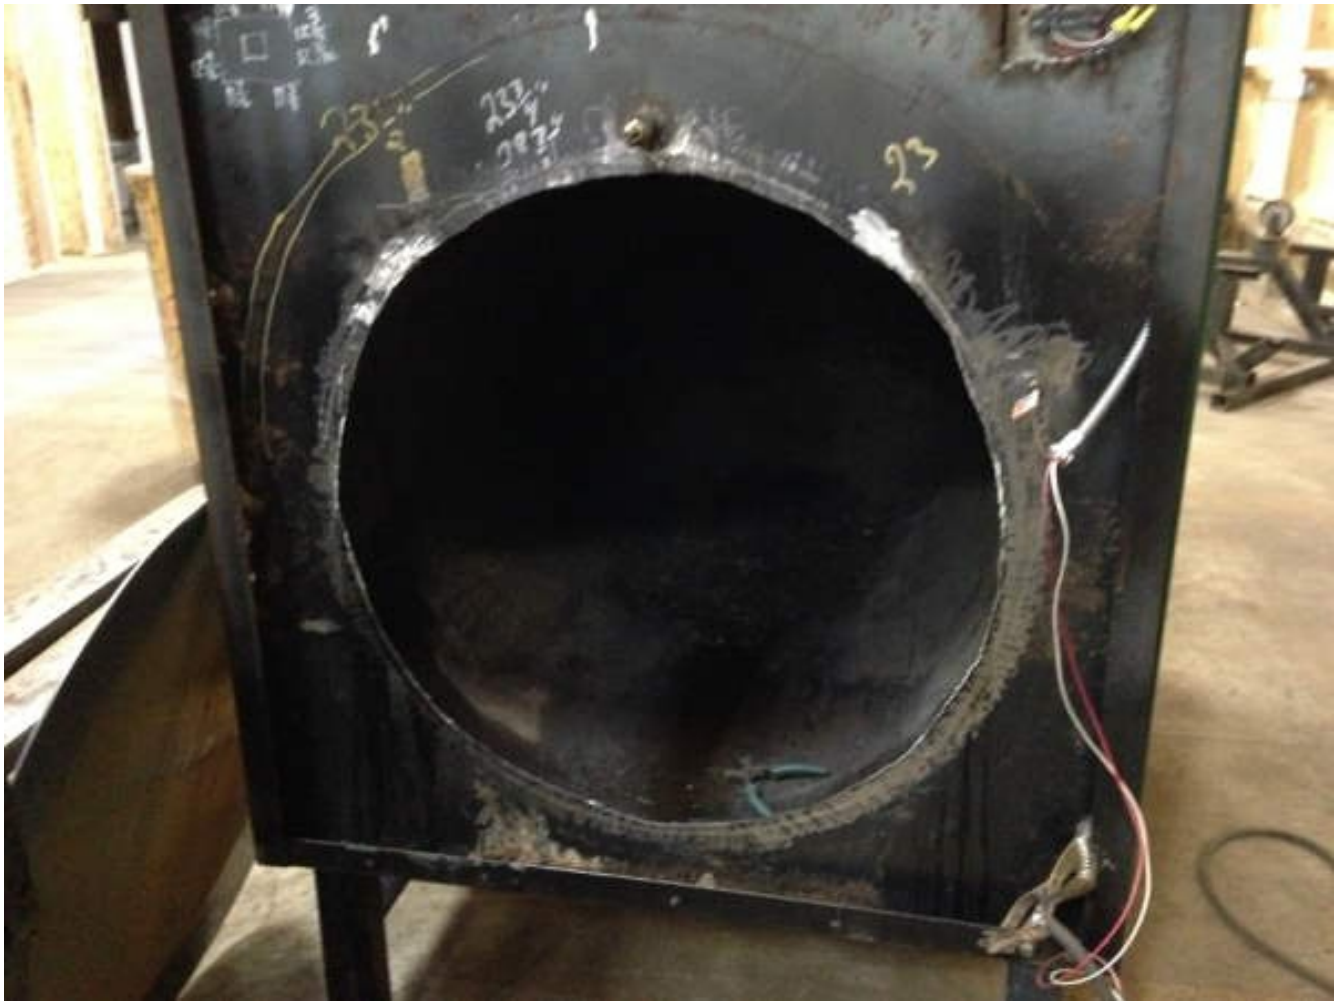
This leaves the stove's water jacket plate only up to the firebox. All cracks are repaired and the water jacket is pressure tested for leaks. This insures the stove will be in good working order when complete.

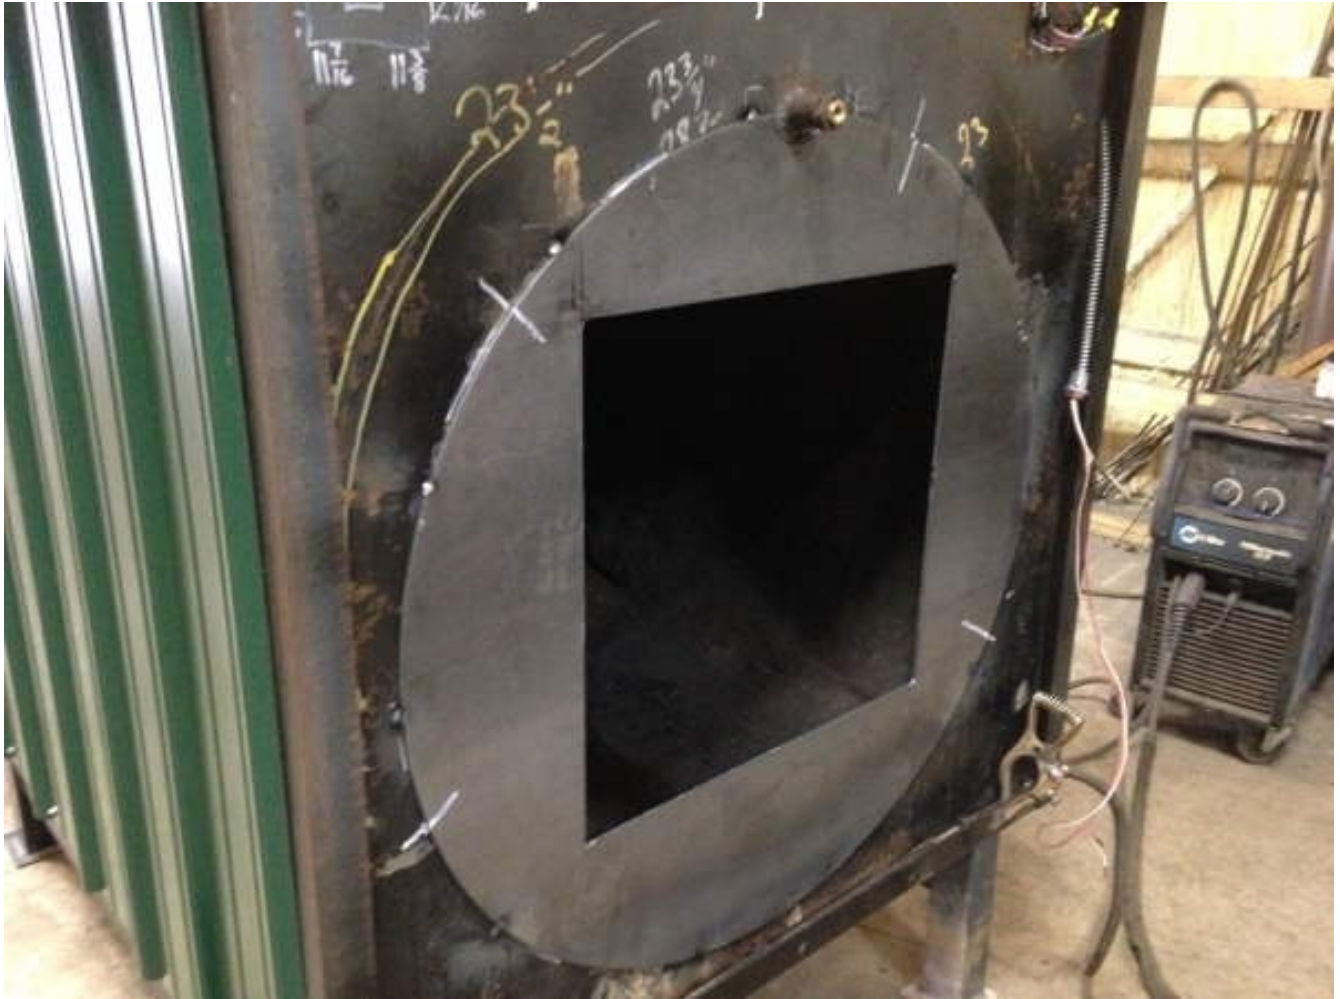
Next we attach a new plate to the front of the stove. The outside diameter is past the opening to allow welding inside and out. The door hole is placed based on the previous measurements to insure proper location on the door frame. We re-pressure test the stove to insure none of the welding has created any new issues and the stove is still properly sealed.

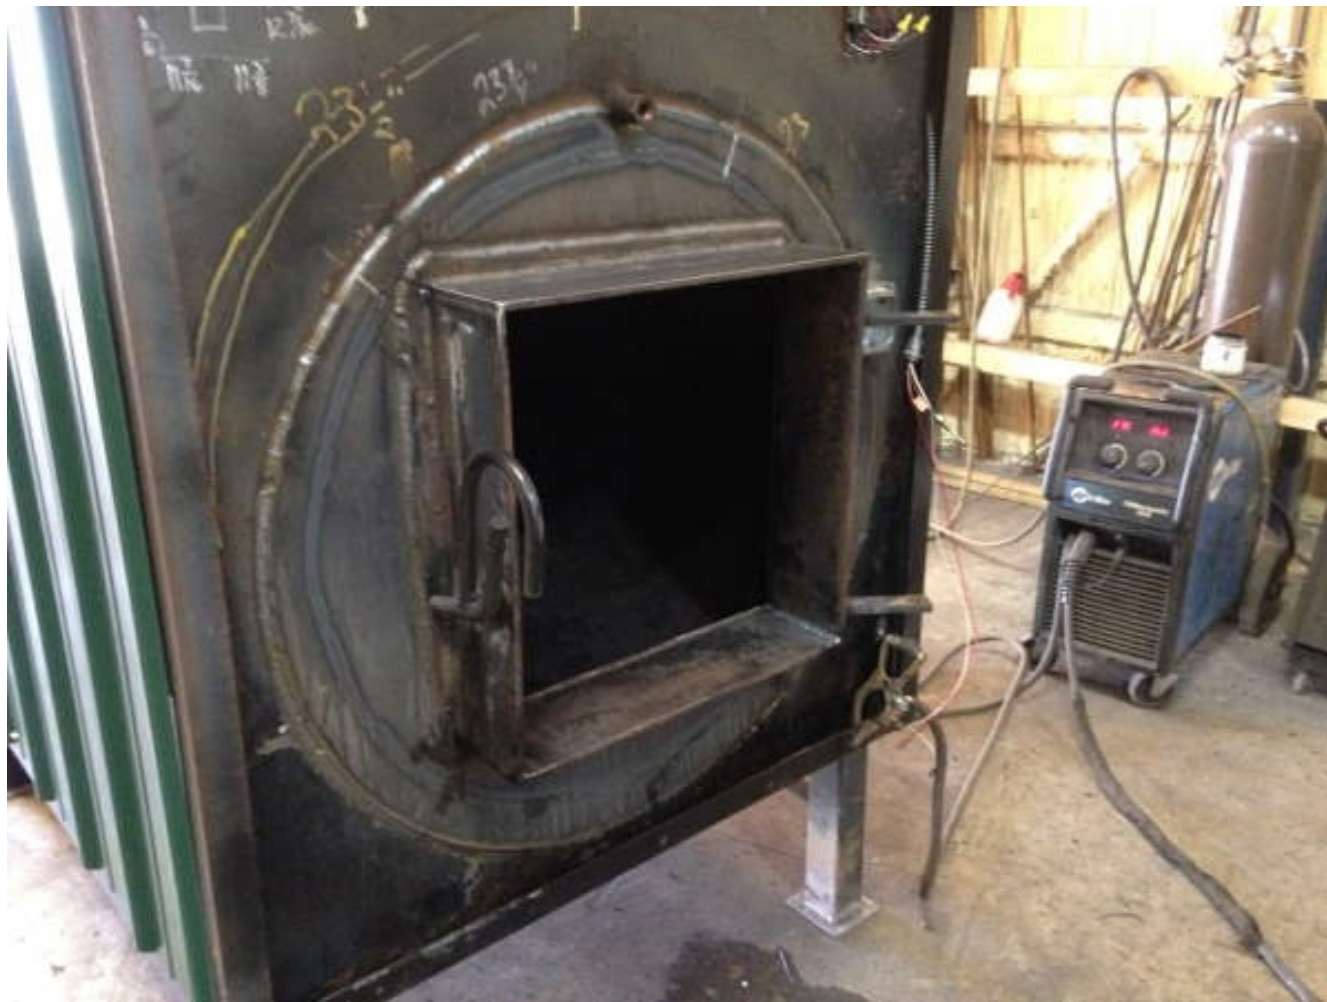
Then the door frame is reattached to the front of the stove. Again the previous measurements are used to insure exact realignment of the door frame. The frame is welded inside and out.

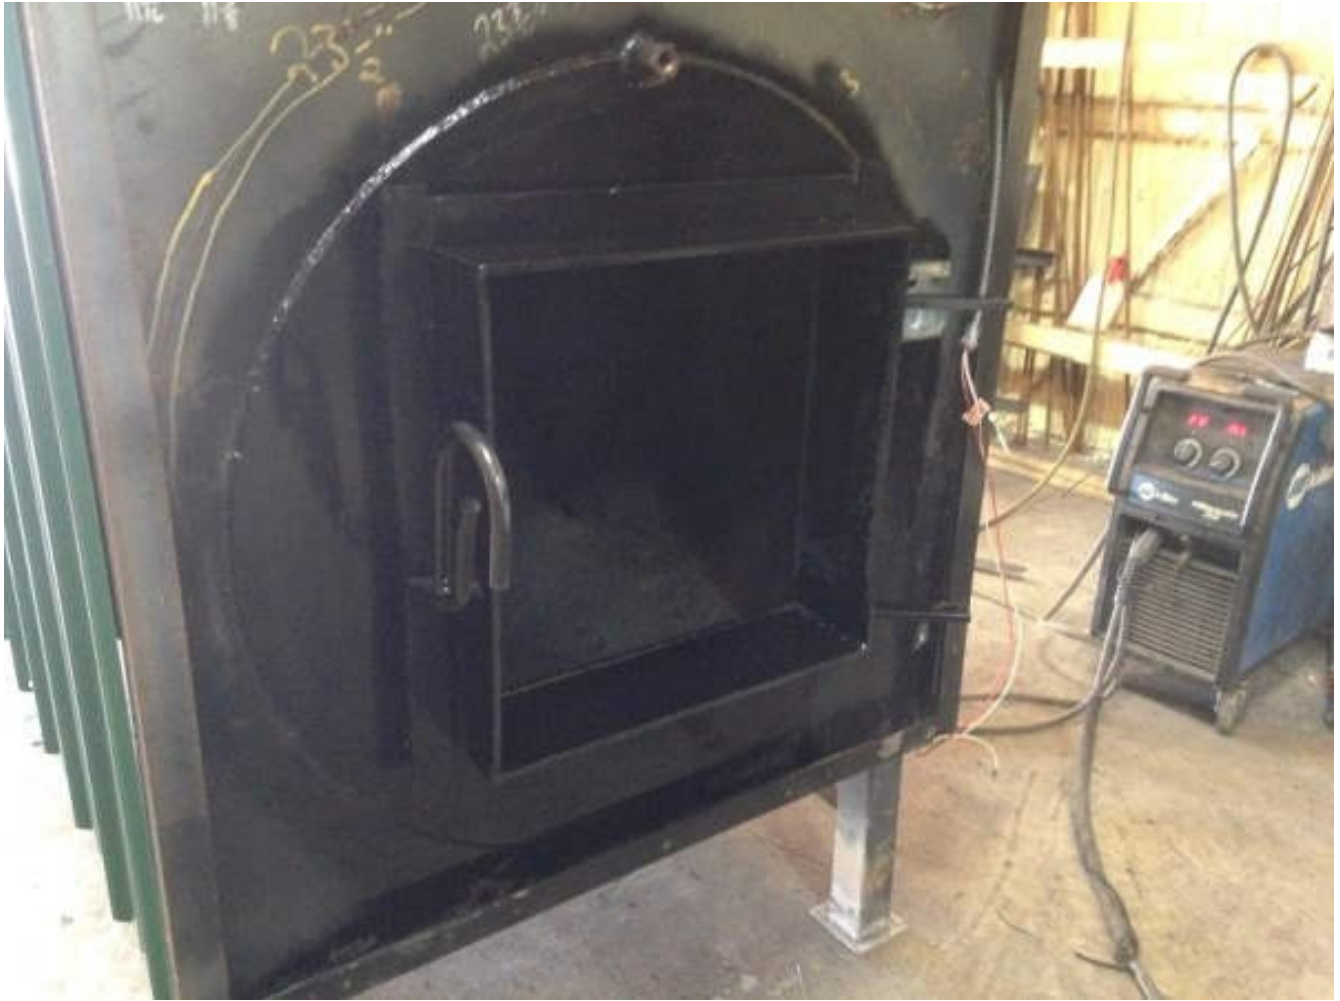
New angle is added for the barn steel, this angle is cut back to compensate for the door frame actually sticking out farther from the new plate. Everything is painted to prevent rusting.

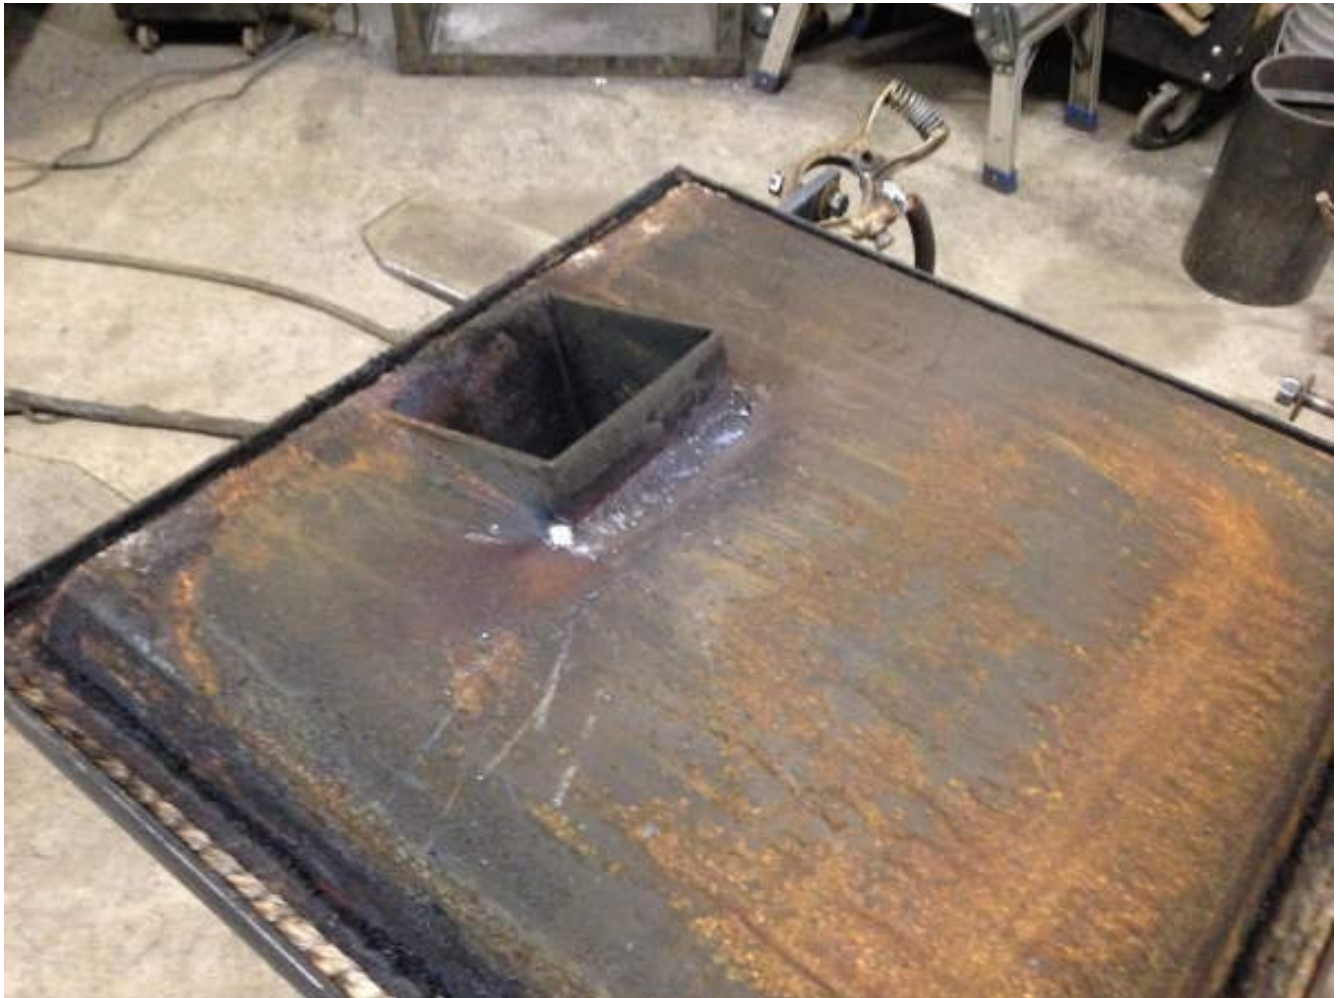
Before the door is put on, it is checked for damage and repaired.

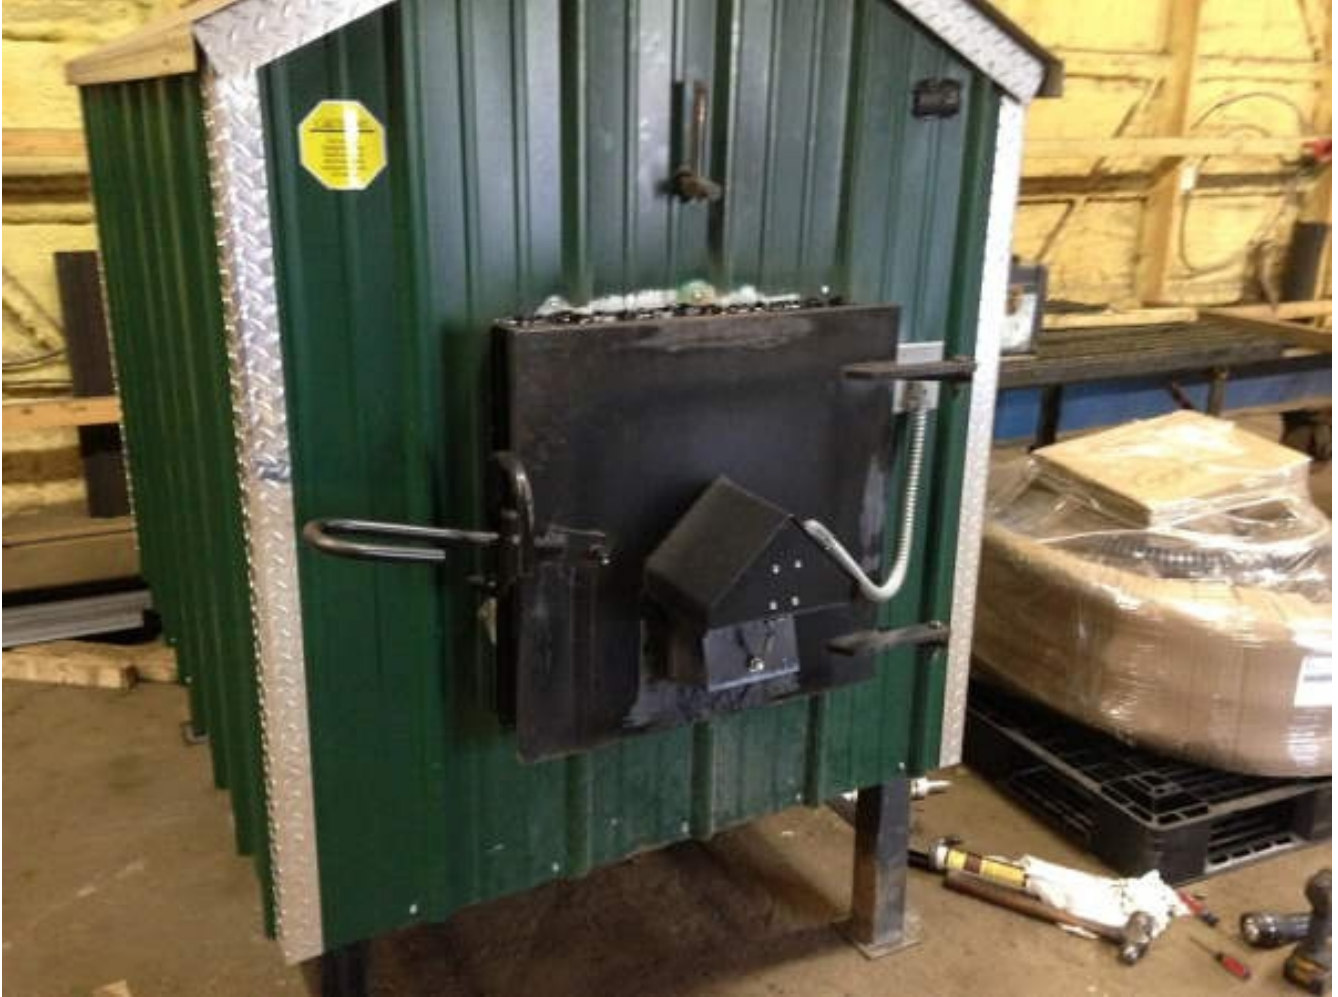
Finally the stove is reassembled, tested, caulked, and ready for service.
